Brook Street Catchment Flood Risk Survey – 23/05/24

DroneEnvironmental Ltd

Brook Street Topographical Base Map:
0.5m contours & 200m grid

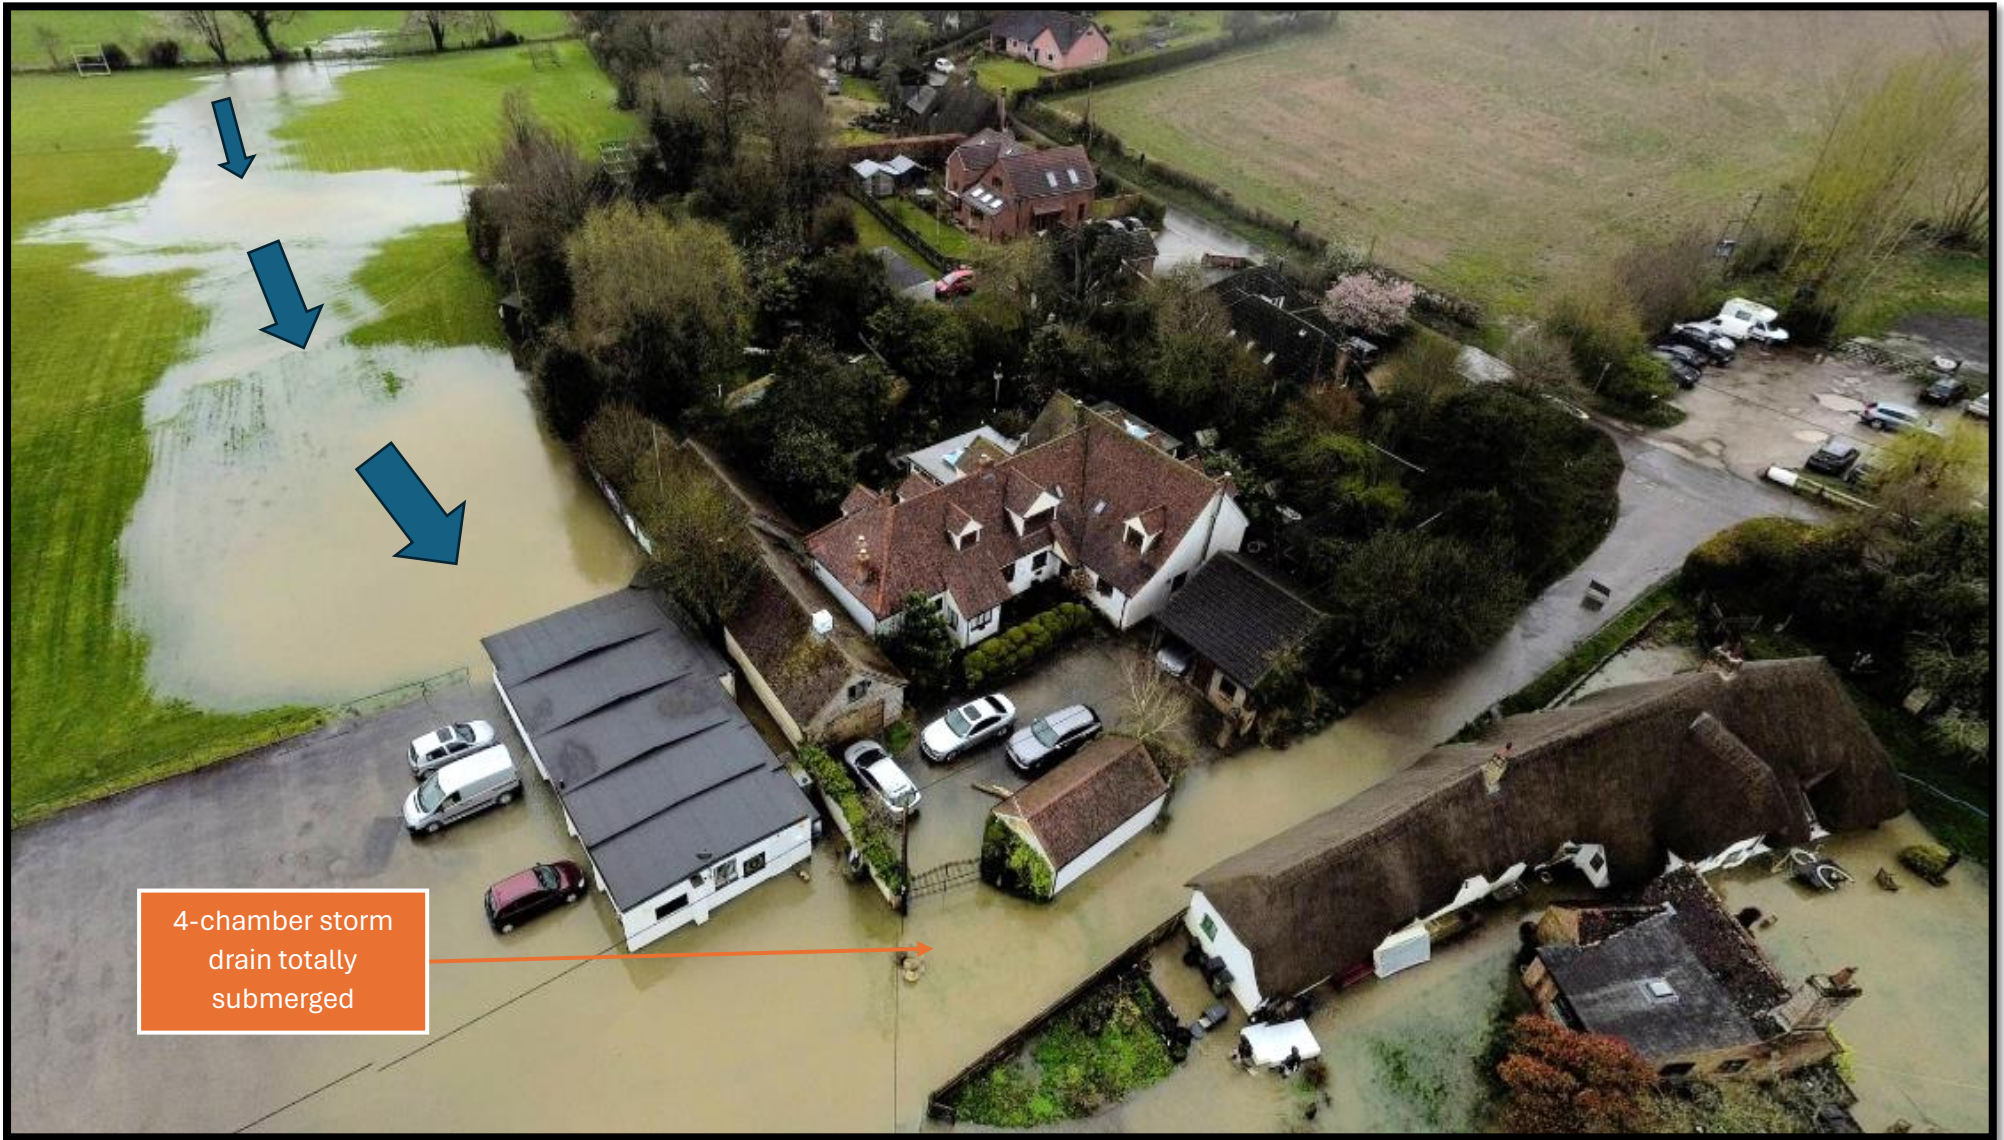
Figure 1: Frog Lane Flooding - 28th March 2024

In the 12 months from 1st April 2023 to 1st April 2024, 9 surface water flood events have impacted the village of Great Bedwyn (source: <https://kuula.co/post/5v3Pg/collection/7JSxj>). In the Brook Street catchment, circa 5 properties have experienced significant and repeated internal flooding. Figure 1 highlights the impact storm water is causing and the need for urgent action.

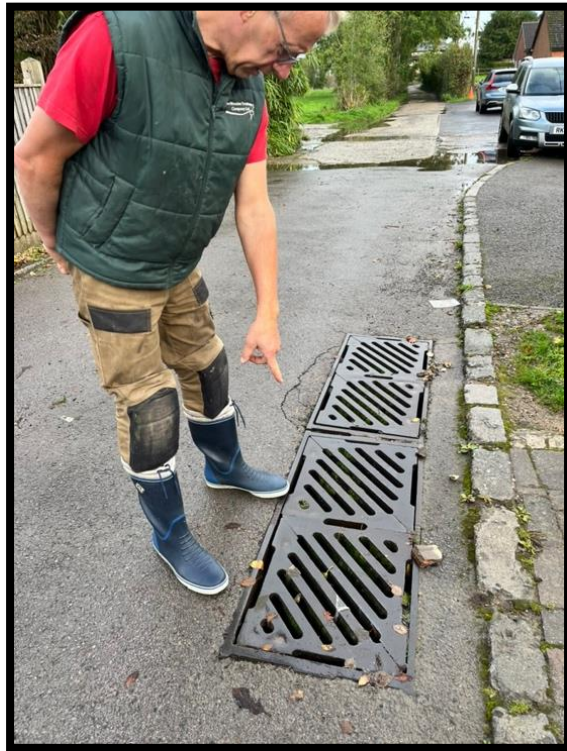
Figure 3: 4-Chamber Storm Drain

- To the south, the siphon is connected by a brick culvert – this is fed by surface drainage from a road drain on the south side of Brook Street
- To the north, the siphon is connected by 2 x 300mm PVC pipes which connect to a 4-chamber storm drain in Frog Lane (Figure 3)

- The 4-chamber drain is the main/only collection point for surface runoff from the cricket club, village hall car park and immediate vicinity

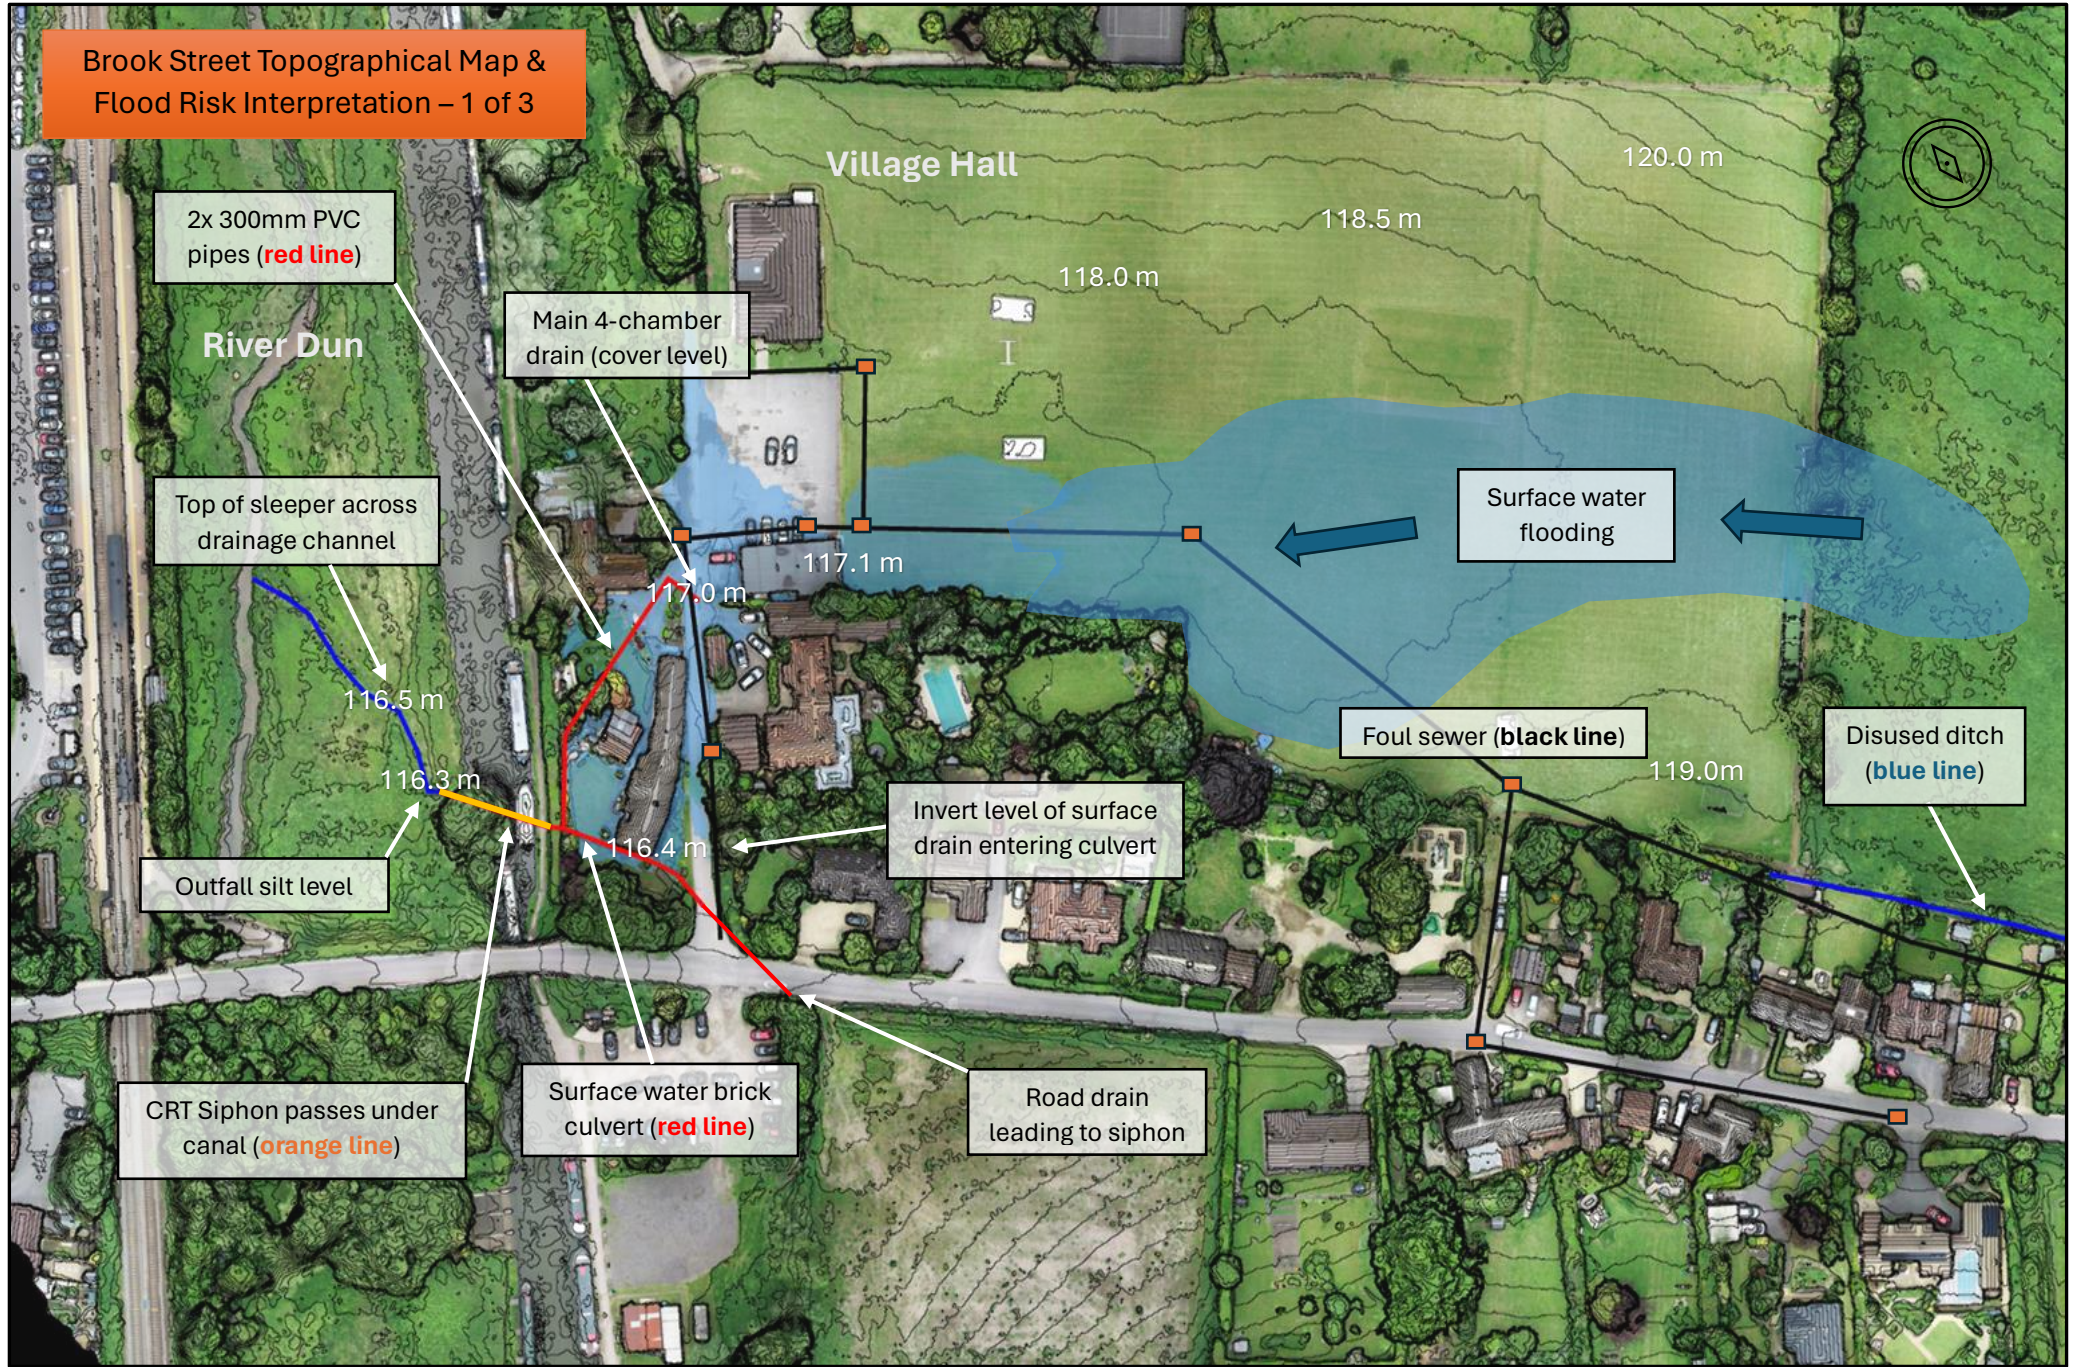
Brook Street Topographical Map & Flood Risk Interpretation – 1 of 3

- A shallow drainage channel (circa 50m long) extends from the outlet of the Canal & Rivers Trust (CRT) siphon (orange line) to the River Dun (blue line)

- The channel is overgrown and silt laden - 15m from the outlet, a sleeper and concrete block slab create a raised ford across the channel
- The CRT siphon is a culvert that passes under the canal, it is the only surface water connection to the River Dun for the entire Brook Street catchment

- The siphon is 600mm in diameter, constructed of concrete and 17.1m long (see Figure 2 for details)
- A recent CRT investigation has identified that the siphon is currently (June 2024) substantially blocked by non-hazardous detritus

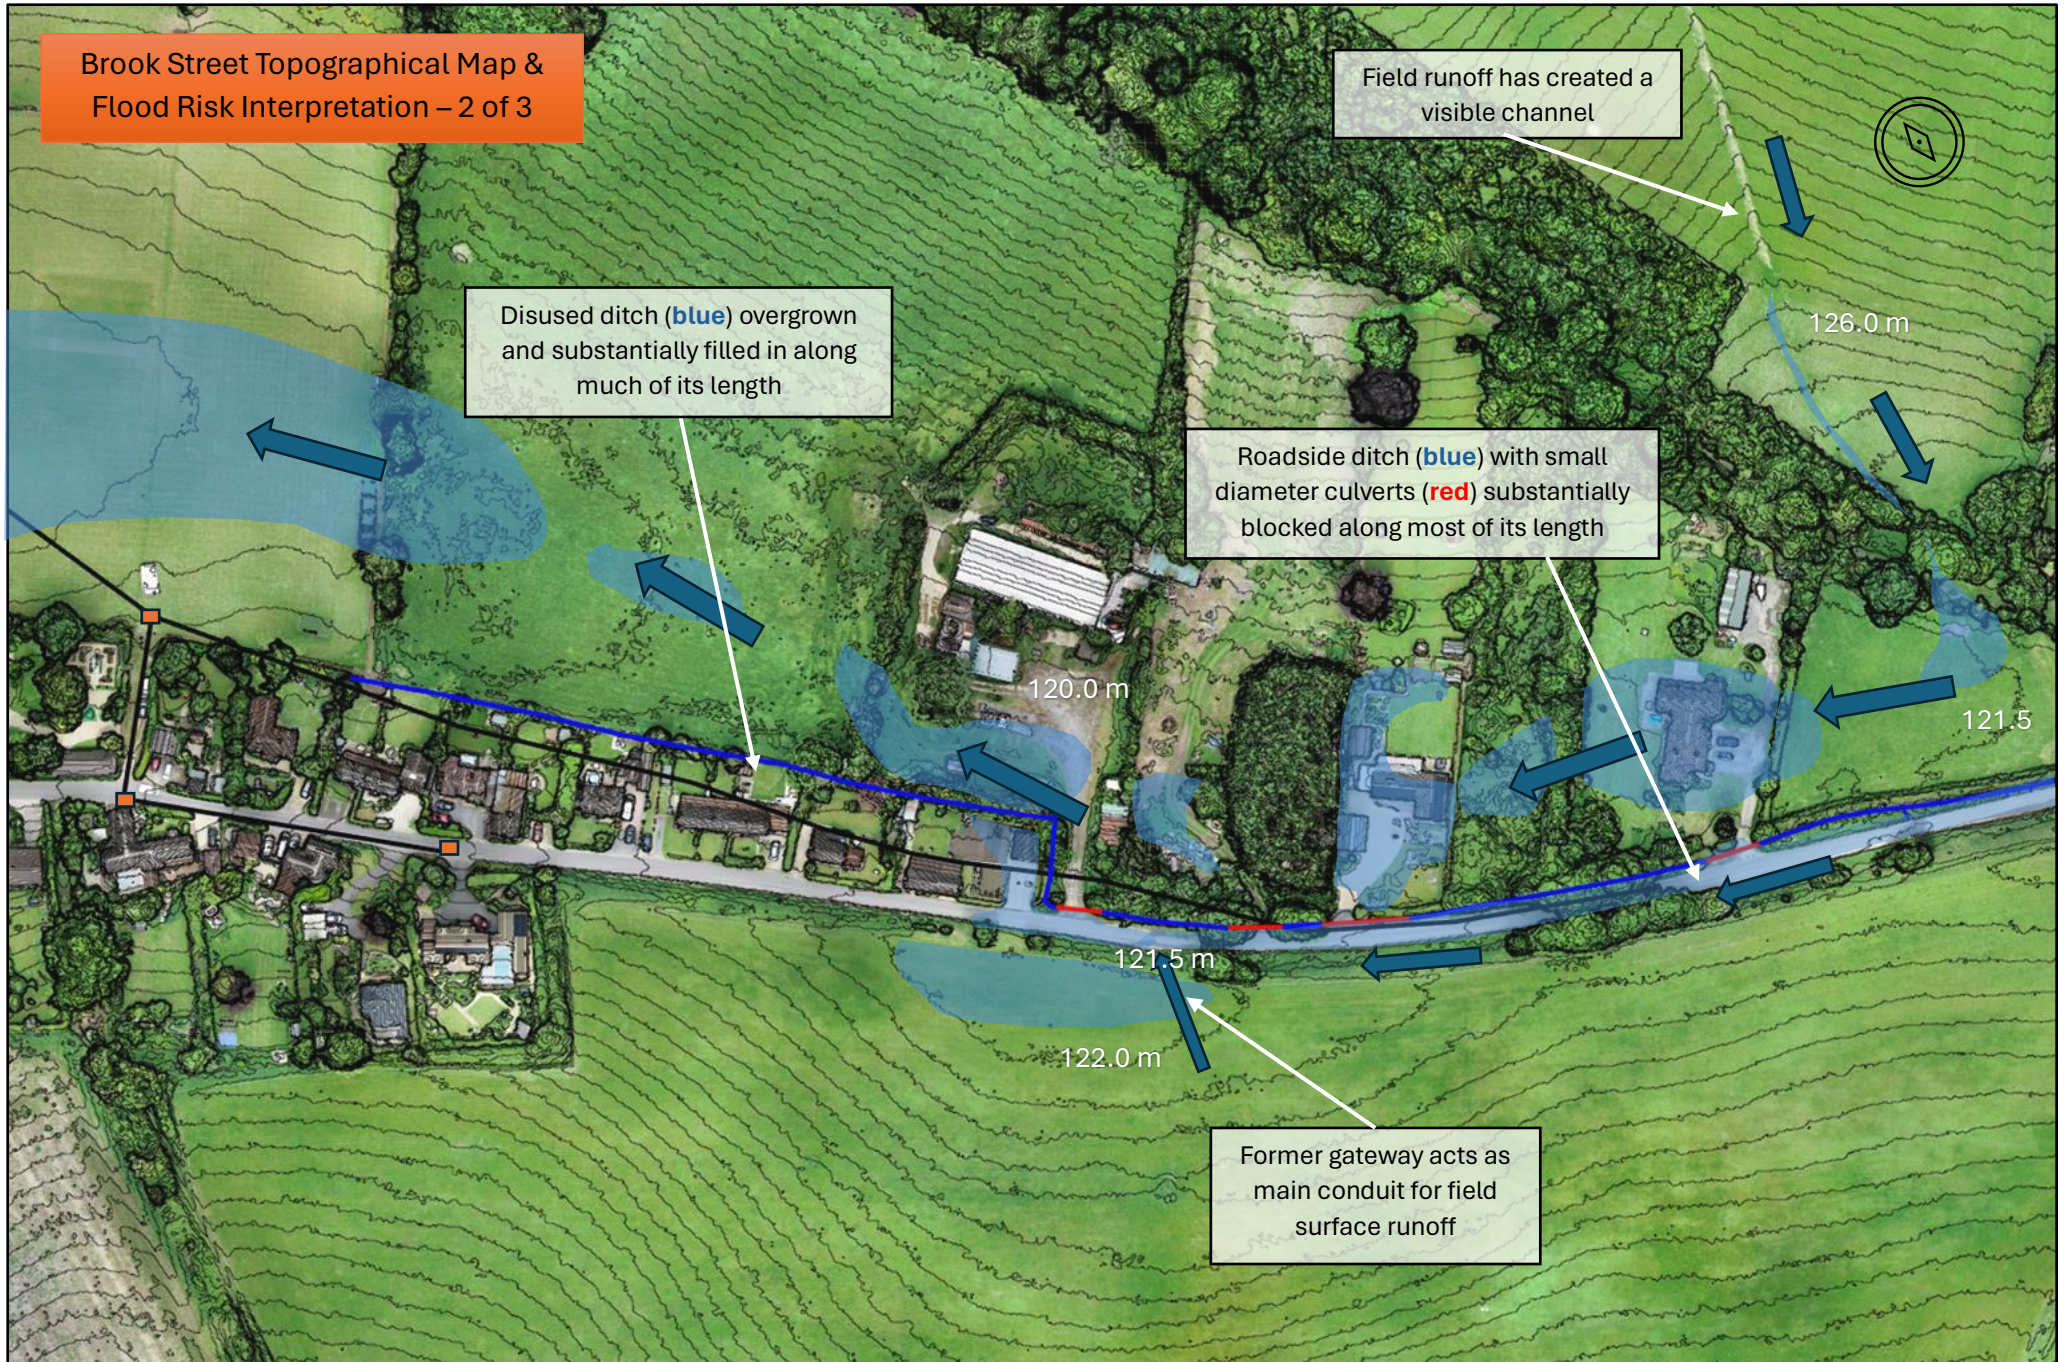
Brook Street Topographical Map & Flood Risk Interpretation – 2 of 3

- The only surface drain (**blue & red line**) is almost completely unserviceable along its entire length
- Surface water flooding impacts the road, the entrance to Meadow farm and the properties in the immediate vicinity (**blue shading**)
- During flooding events, surface water runoff from the field to the south of Brook Street discharges through a redundant gateway directly onto the road
- Video evidence of the flooded road and field runoff can be viewed at <https://www.youtube.com/watch?v=XsftyEOU3-A>

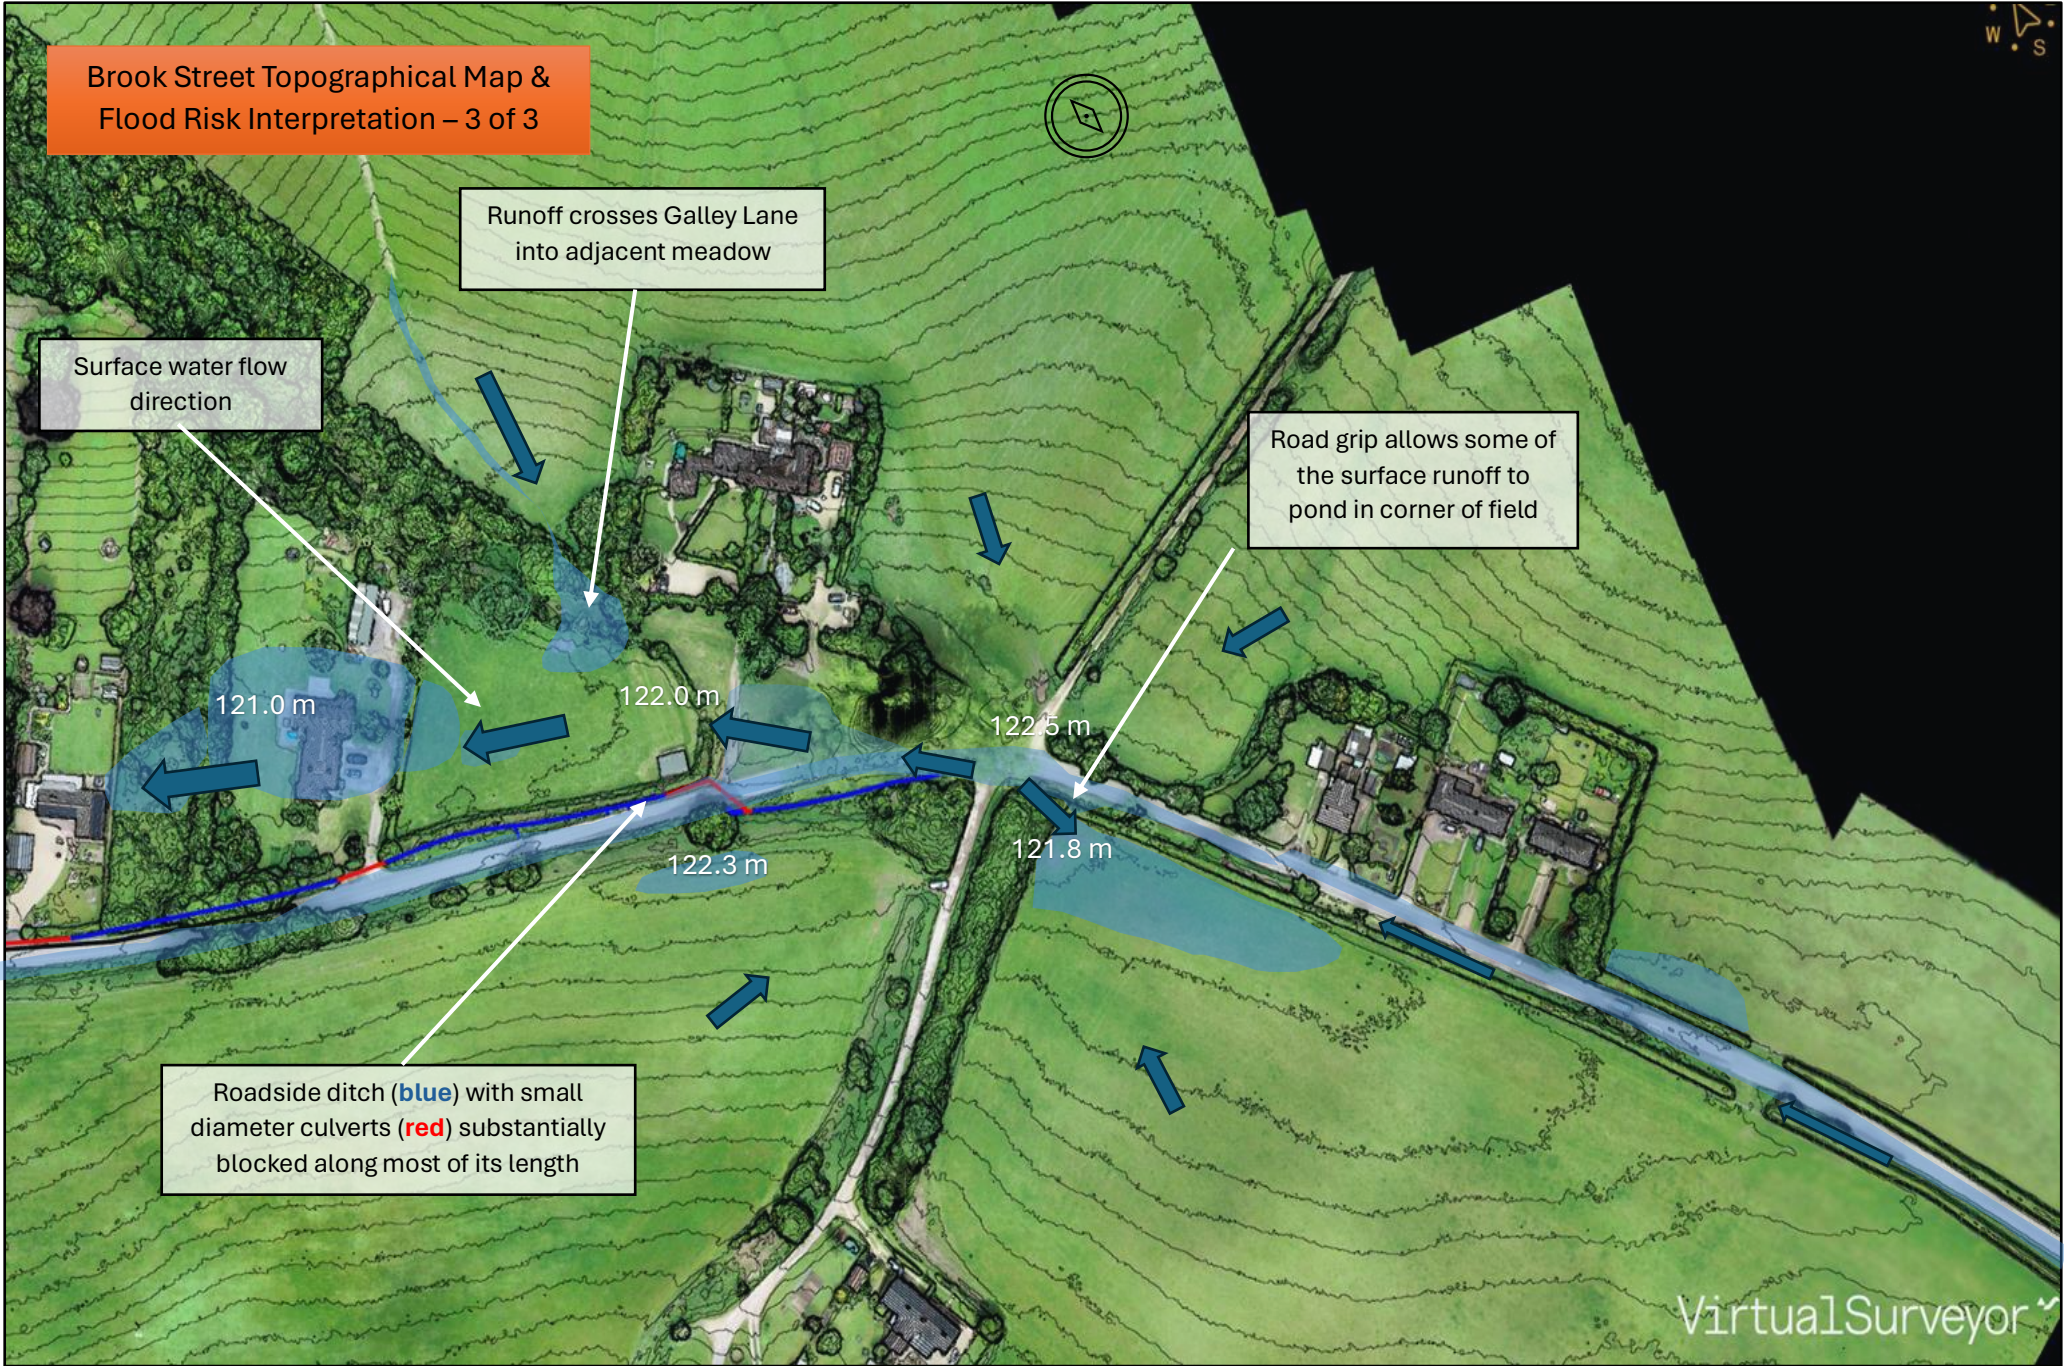
- The topography at Jockey Green concentrates catchment runoff from the north, south and east
- The centre of surface water concentration is the green, the main road and the field to the southeast
- Runoff from the field to the north has gouged a visible drainage channel in the shallow soil surface
- The runoff from the north passes across Galley Lane (Bridleway) and into the adjacent meadow
